Feasibility Study & Long Range Plan Norwood Public Schools

Town of Norwood, MA

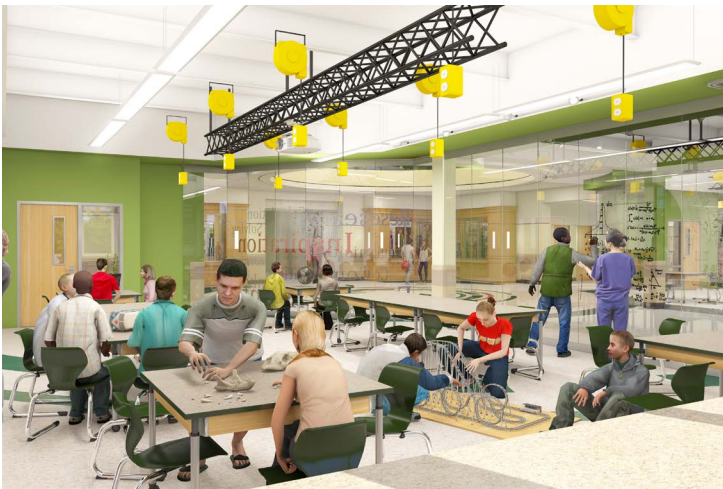
Example of a flexible project lab and instructional space in present-day school design

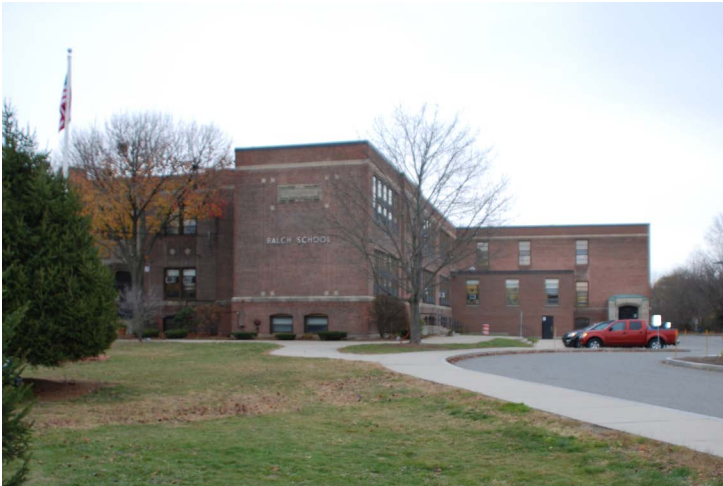
Despite the inherent charm of Balch Elementary School, the building requires a comprehensive renovation due to its age

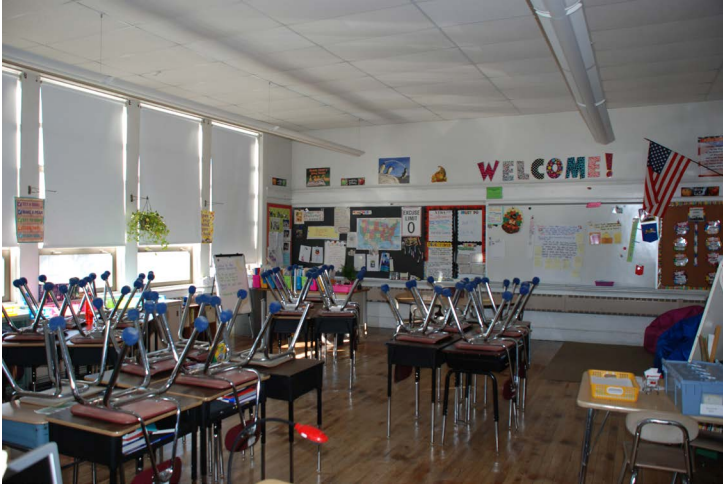
Classrooms are small and do not include common areas for student projects, exhibits, or team teaching

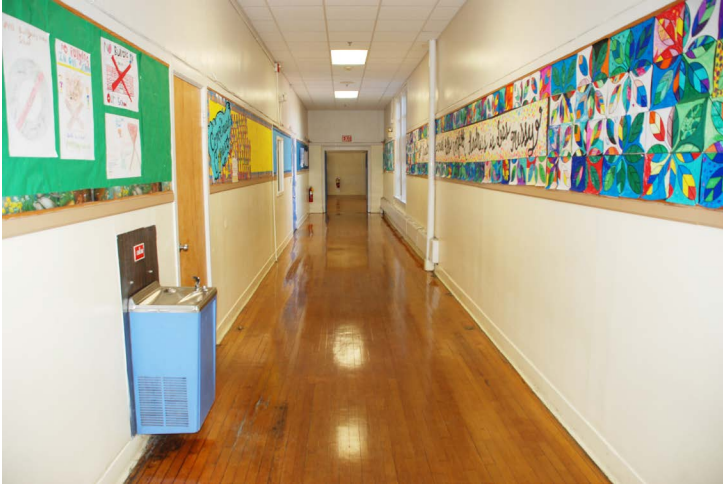
The hardwood floors in the corridors and classrooms are mismatched in appearance, squeaky, and require refinishing

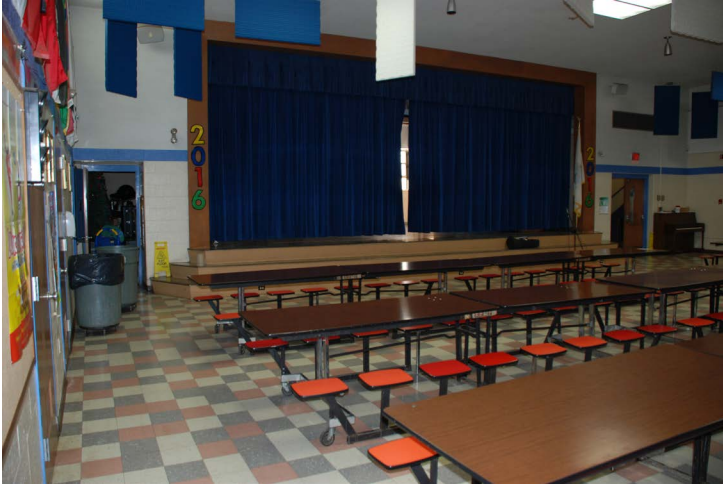
Student dining is one such area still containing Vinyl Asbestos Tile (VAT), a hazardous material

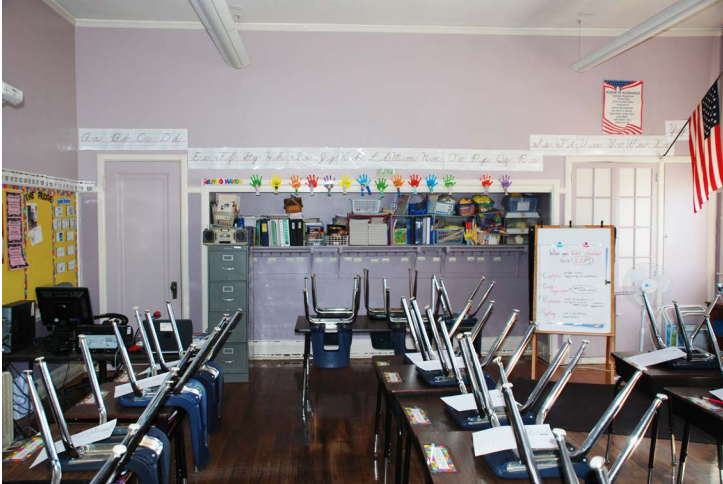
Though full of charm, the classrooms at Callahan are insufficient in size, lack flexibility, and contain no support spaces

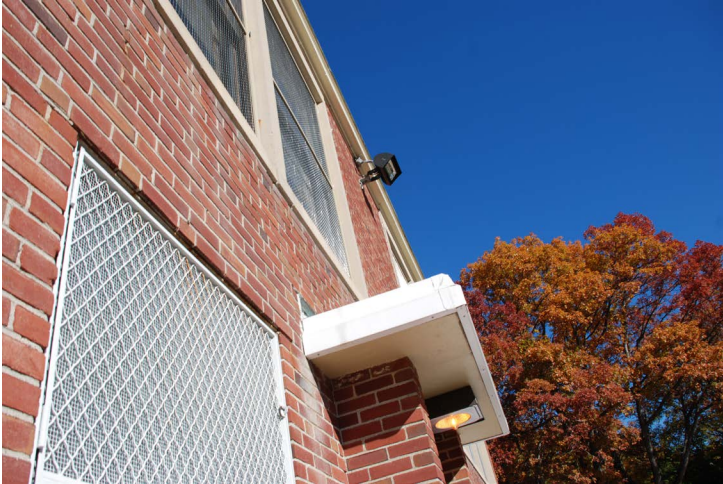
The exterior envelope has seen little change since its original construction

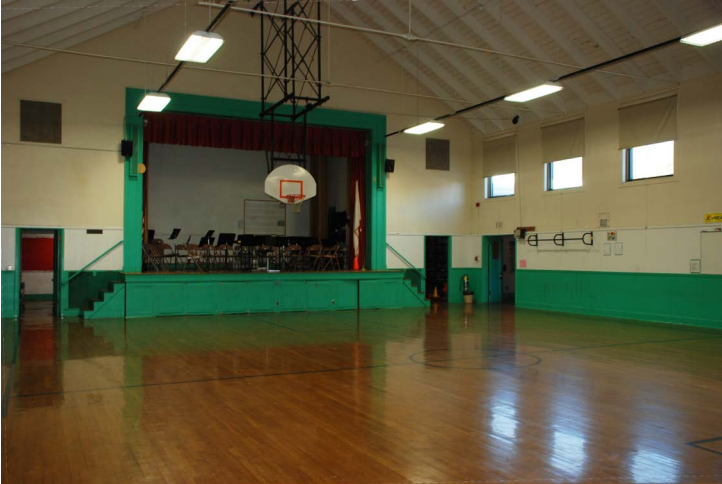
The roofing system over the gymnasium is pitched and covered with asphalt shingles

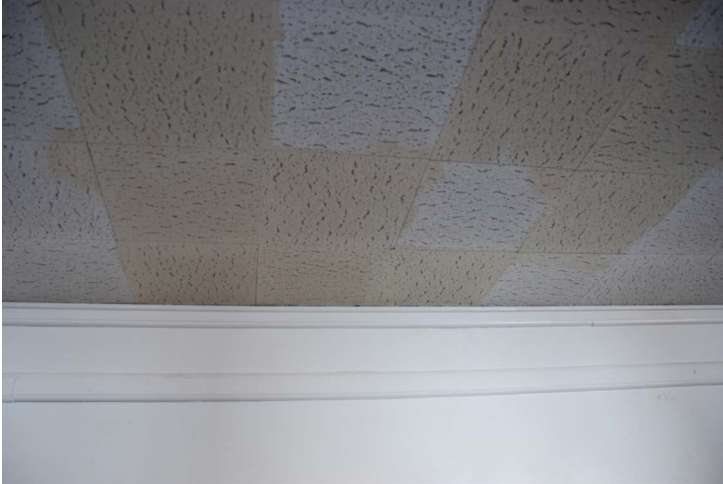
The main floor corridors are finished with Asbestos Ceiling Tile, a hazardous material, that show signs of water damage

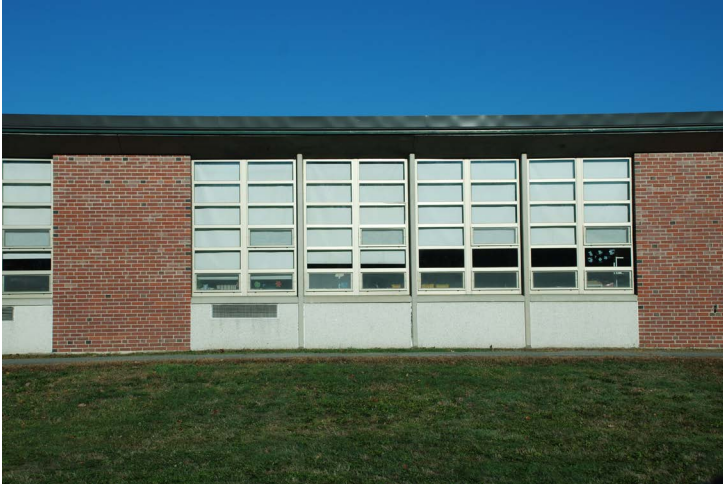
The exterior envelope is composed of brick bays and continuous stacked window units within a pre-cast concrete infill system

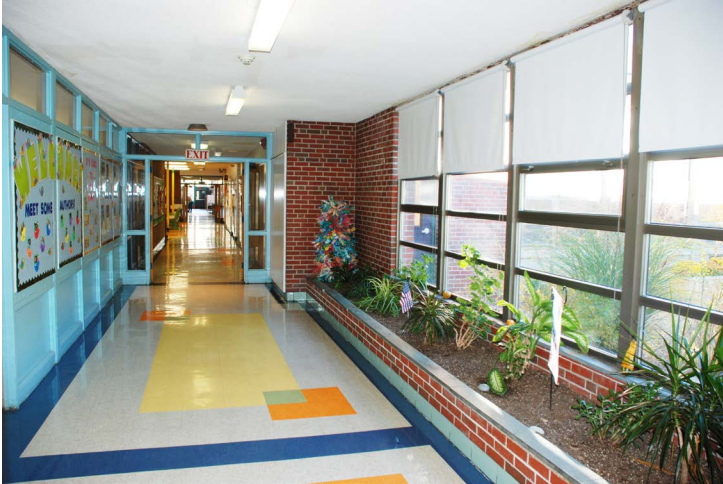
The most recent capital improvements for lighting and flooring are still in good condition

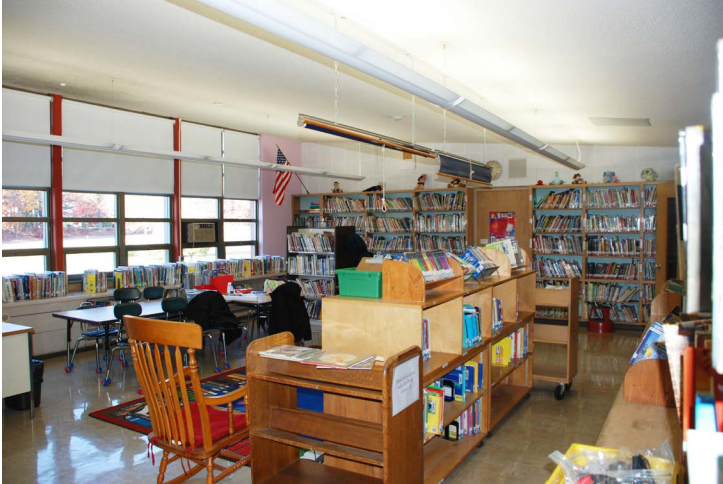
The library media center is centrally located, but under-sized and lacks modern amenities and resources

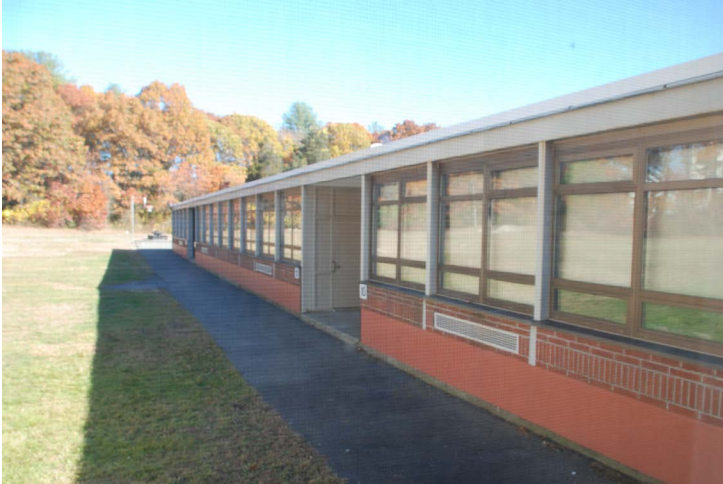
Due to the change in grade between the three winds, exposed foundations walls are obvious

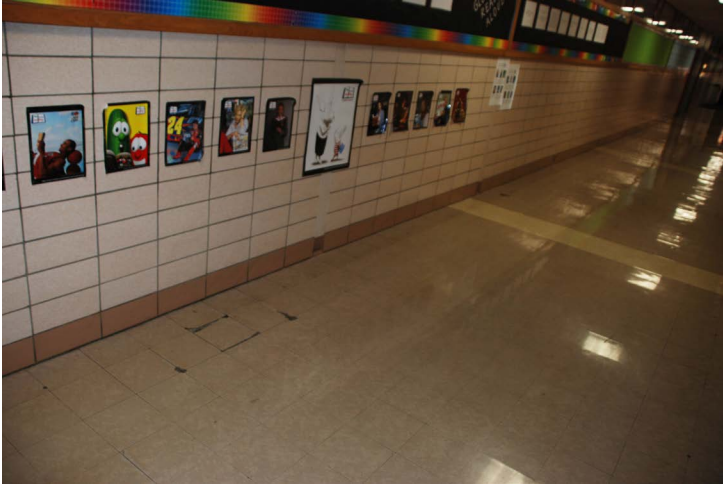
The Vinyl Asbestos Tile (VAT) throughout the corridors is a hazardous material that will cause harm upon degradation

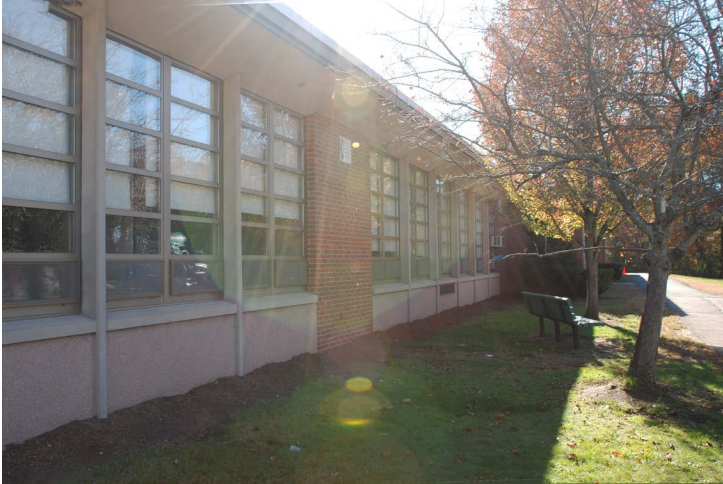
A portion of the infill pre-cast panels along the exterior envelope are designed with an intake grille for mechanical ventilation

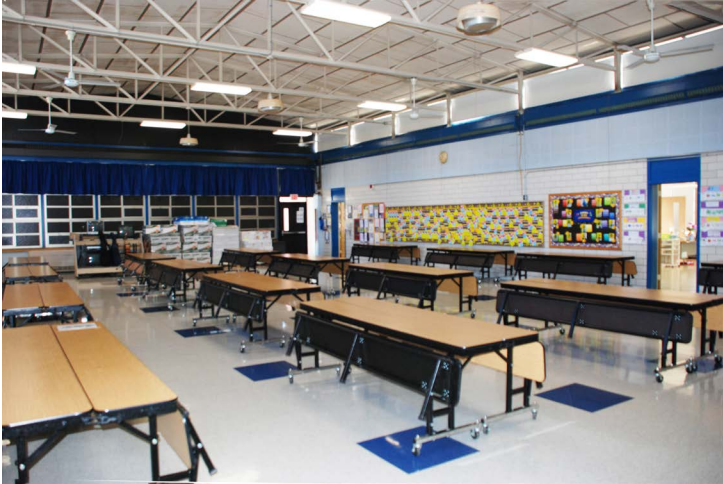
Flooring in student dining was replaced from hazardous Vinyl Asbestos Tile (VAT) to Vinyl Composition Tile (VCT)

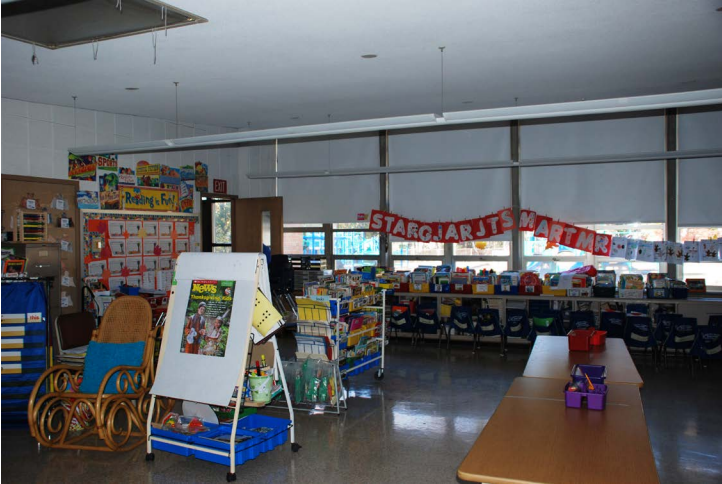
There is no integration of planning or collaboration space throughout the school, for either students or staff

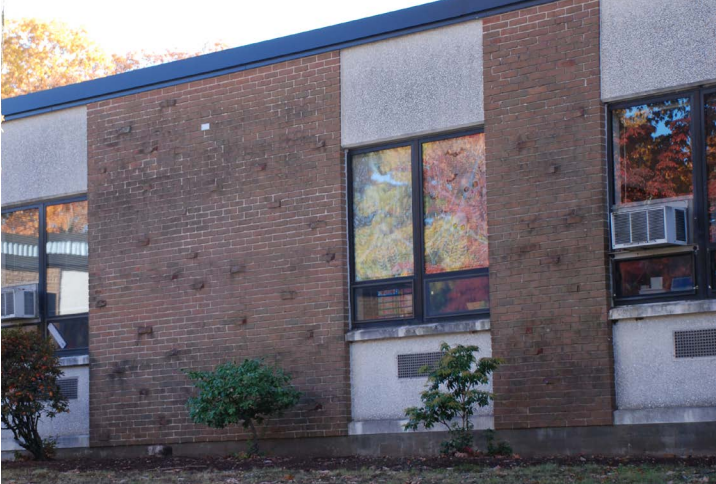
Though masonry facade repair is a recent capital improvement, the mortar appears to have receded since

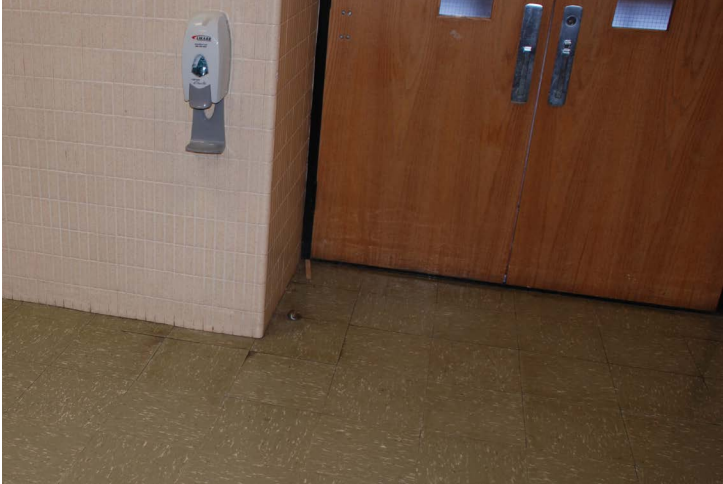
Almost all flooring materials are Vinyl Asbestos Tile and the varying thresholds between could pose accessibility challenges

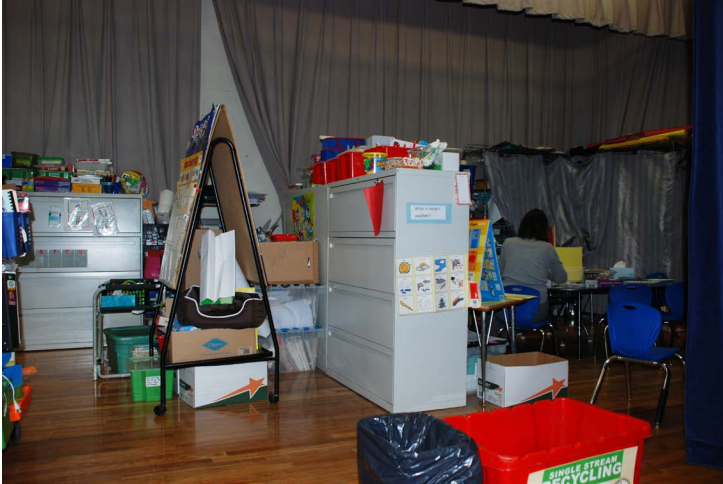
Community spaces, like student dining and its stage, have been compromised in order to accommodate academic programs

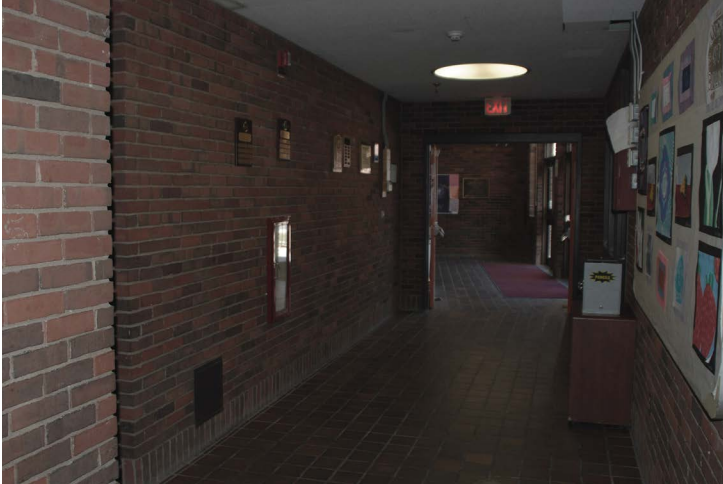
Students in middle school face significant social, educational, and psychological challenges as they transition from elementary to high school; none of which are facilitated by the design of Coakley Middle School

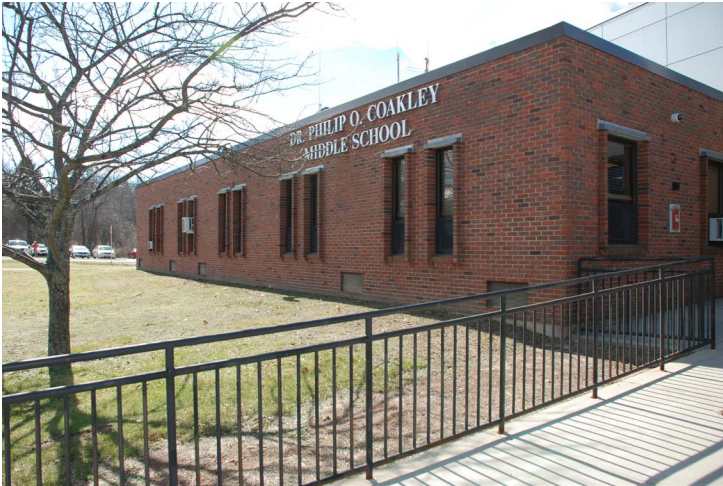
Unlike masonry walls today, no cavity between the brick and masonry back-up exists, which can lead to thermal and moisture issues

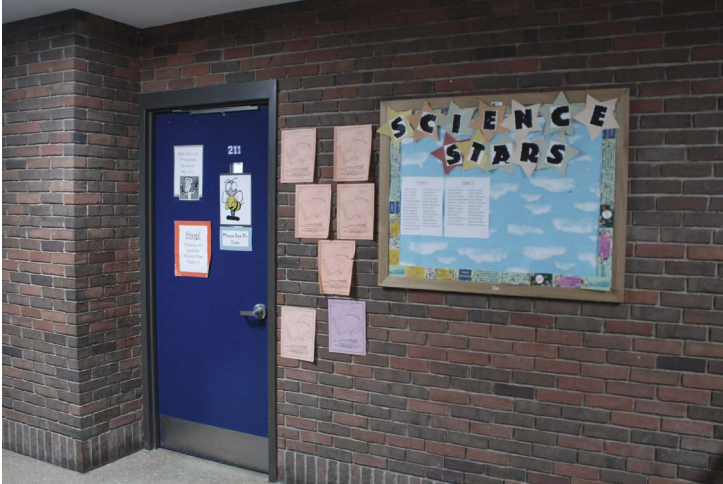
Typical classroom entries along the corridor offer no sense of activity or personality and are essentially uninviting

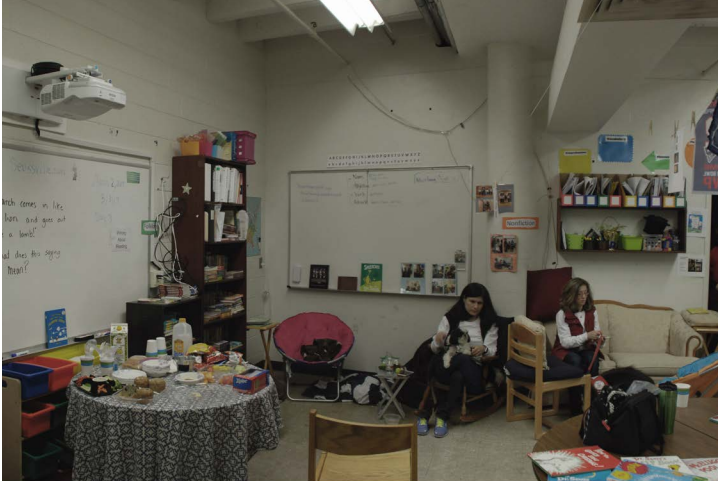
Rooms originally unintended as classroom space are being used as such, without access to fresh air or daylight

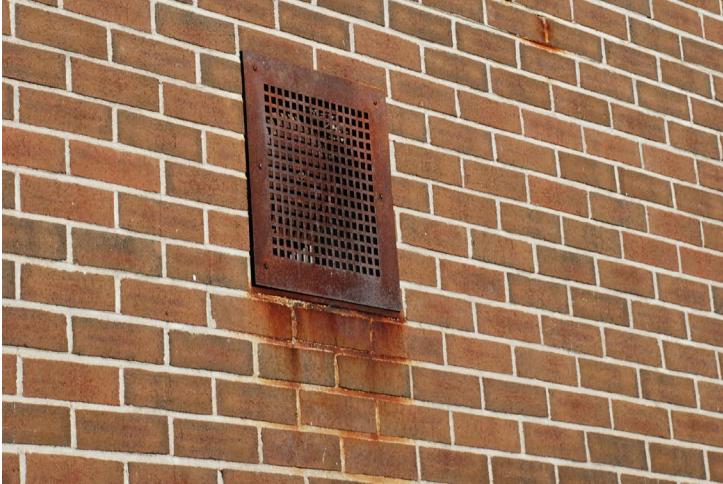
Exterior walls at the Savage Center show the results of no weeping system or cavity wall construction

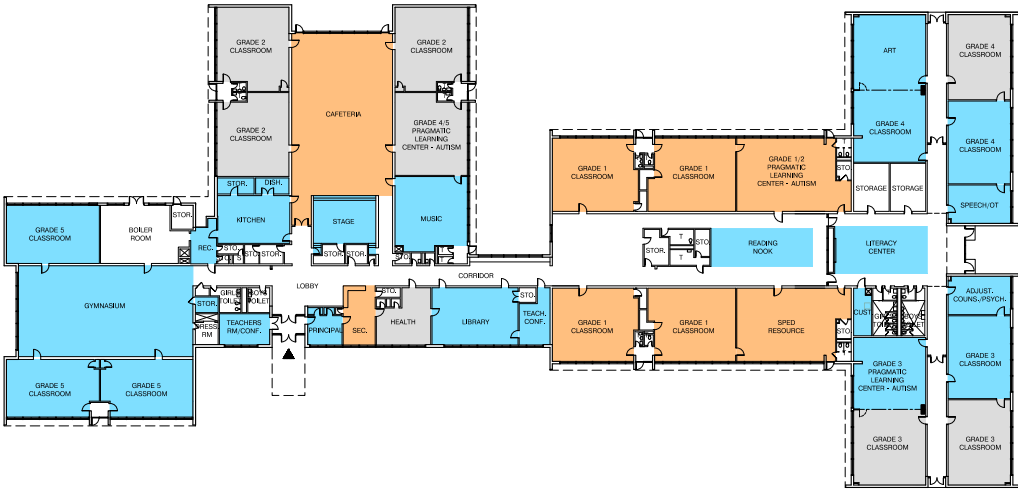
sf = MSBA guidelines
 sf > MSBA guidelines
 sf < MSBA guidelines

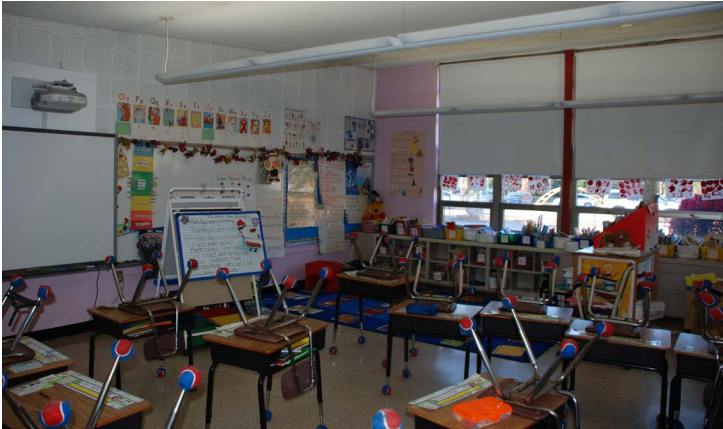
Tight square foot per student ratio

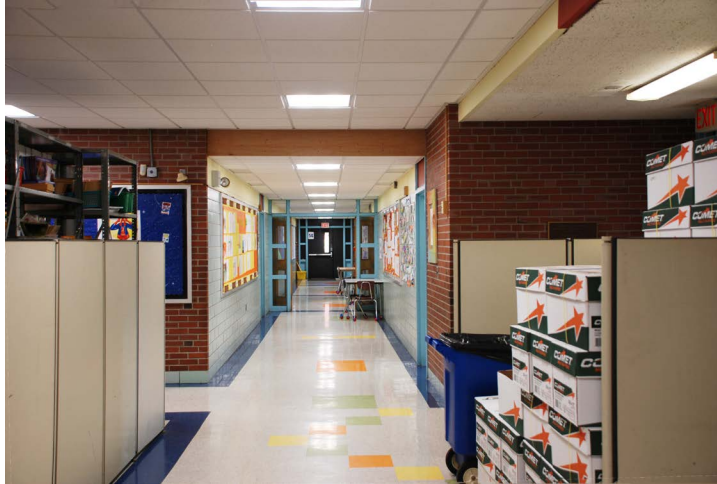
Corridors are full of paper and books - items that create a safety hazard

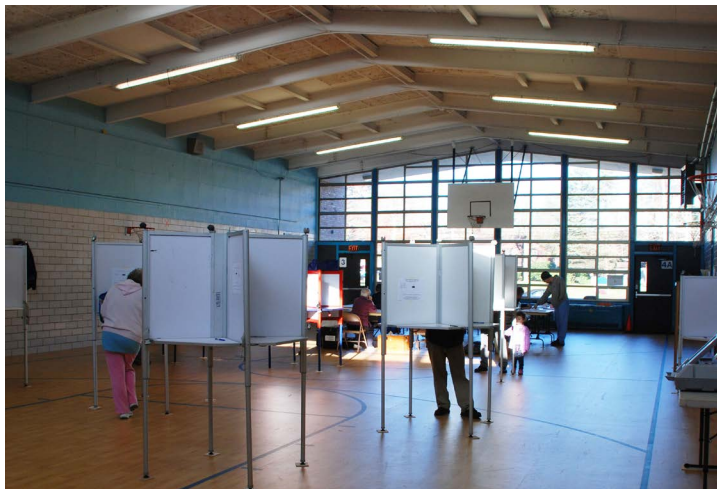
Community spaces, like the gym, were not increased when the 1965 addition was constructed

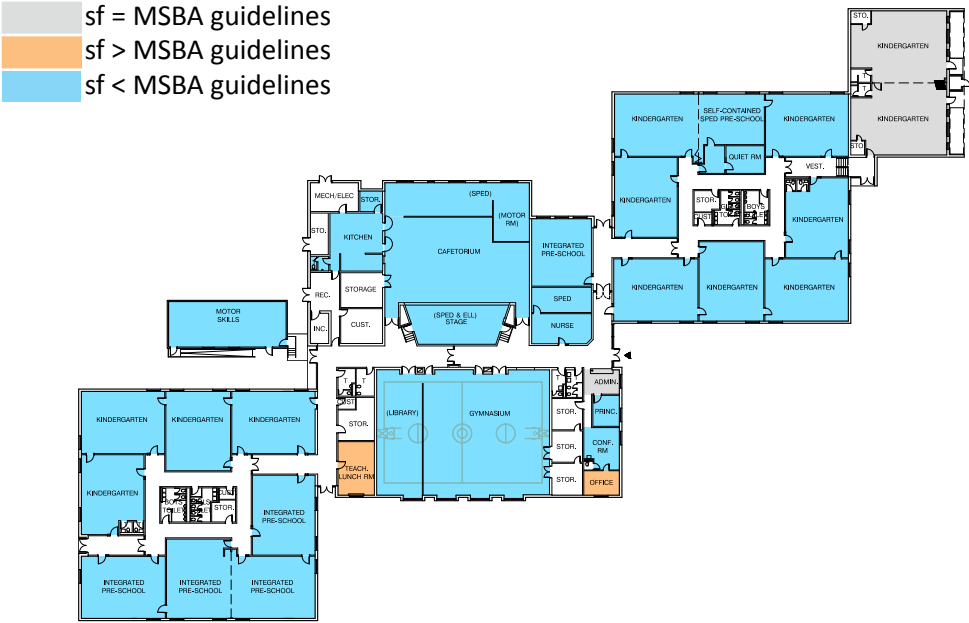
- 385 students
- 38,500 square feet

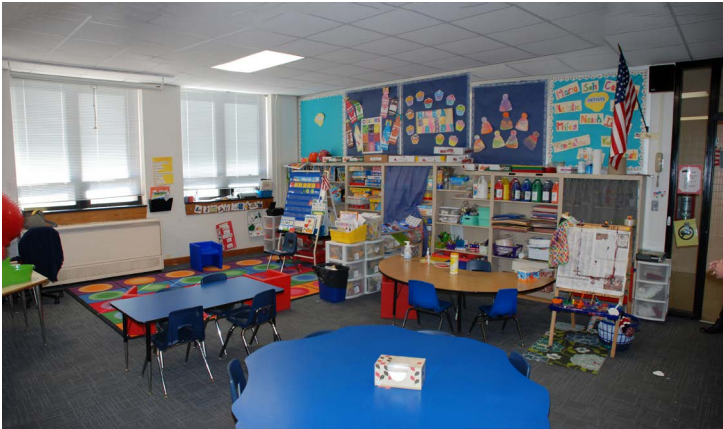
Under-sized classrooms

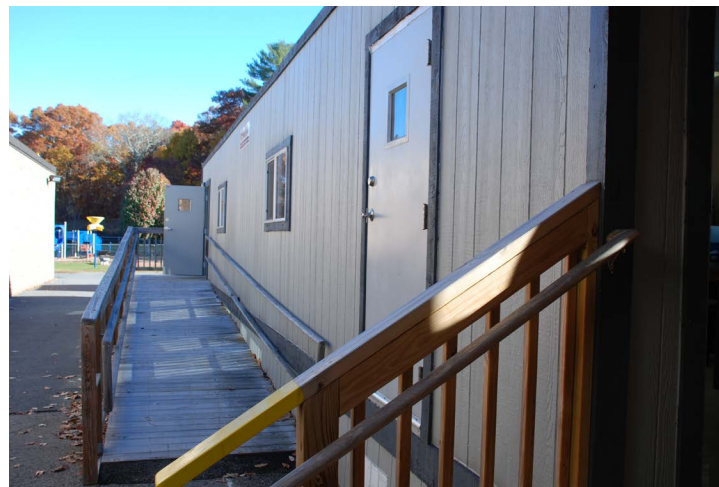
The trailer is inadequate to comfortably provide educational space, and has become a permanent fixture
